DEPARTMENT OF TRANSPORTATION**DIVISION OF ENGINEERING SERVICES**

Office of Structural Materials

Contract #: 04-0120F4Cty: SF/ALA Rte: 80 PM: 13.2/13.9File #: 69.15**SOURCE INSPECTION REPORT****Resident Engineer:**Pursell, Gary**Address:** 333 Burma Road**City:** Oakland, CA 94607**Report No:** SIR-002508**Date Inspected:** 12-Jul-2010**Project Name:** SAS Superstructure**OSM Arrival Time:** 700**Prime Contractor:** American Bridge/Fluor Enterprises, a JV**OSM Departure Time:** 1900**Contractor:** Zhenhua Port Machinery Company, Ltd (ZPMC), Changxing Island **Location:** Shanghai, China**Quality Control Contact:** Mr. Don Walton**Quality Control Present:** Yes No**Material transfer:** Yes No N/A**Sampled Items:** Yes No N/A**Stock Transfer:** Yes No N/A**OK to Cut:** Yes No N/A**Rebar Test Witness:** Yes No N/A**Delayed/Cancelled:** Yes No N/A**Other:** Coating Inspection**Bridge No:** 34-0006**Component:** See Below**Bid Item:** 77, 78, 79**Lot No:** B #204**Summary of Items Observed:**

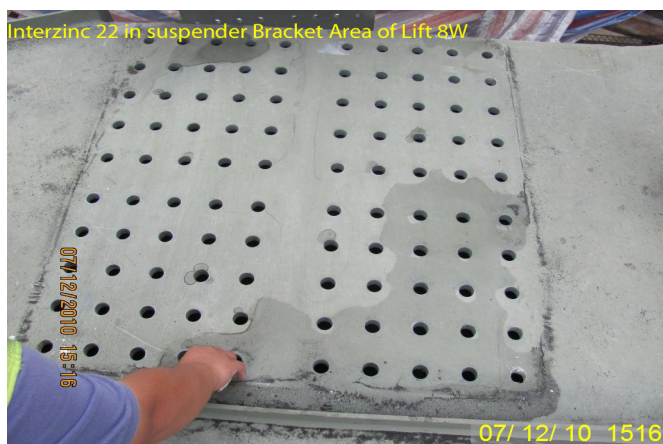
3. This Caltrans Quality assurance (QA) inspector Mr. Baskar Govindarajan Observed on Lift 8 West at OBG assembly yard, Suspender Bracket No. SB 66 erected with Interzinc 22 finish. As per discussion with ABF Inspector Mr. Shi Stone, this is in Primer stage for the last 15 days. As per Surface preparation and painting procedure PQWP-P-001, Rev. 4, Section 8.4.6, The maximum time permitted for Mist coat after Primer is 14 days. Upon discussing this issue with International paint representative Mr. Lou Qian Chuan, He suggested to apply sand paper feathering on the surfaces and conduct Residual chlorides test. If the test results are within the acceptable limit specified in the Contract, ZPMC can go for Mist coat. Informed the same to Mr. Aaron Prichlik and ABF Inspectors verbally. Photograph showing the suspender Bracket in Interzinc 22 is attached.
